**Customer: Papermill**

**System/Product: AWC 442-31 Split Seal, 9k Acetal Bushings and AWC SP50 Flow Meter**

## CUSTOMERS CHALLENGE

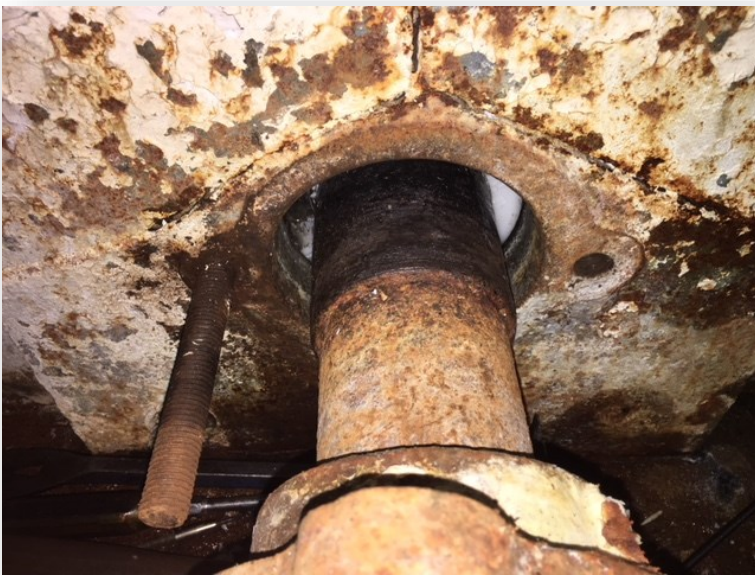
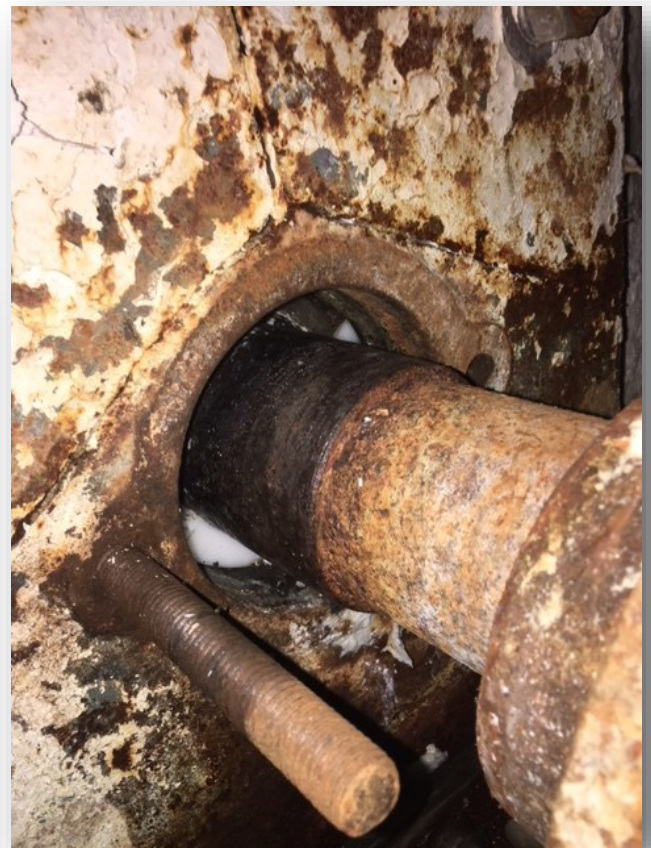
A “broke” chest collects the excess paper stock that falls off the paper machine. It is expensive stock because it has already been refined and treated (basically finished stock). The chest agitator had a shaft that dropped and the packing had been leaking for years. Finished stock had been literally going down the drain and being wasted. Not to mention the treatment cost incurred.

The papermill could not have the shaft or stuffing box changed so we had to work with the existing conditions. The bore was too big so we made a SPLIT ADAPTER PLATE to fit the seal onto the mixer.

The first step was to measure the leakage and provide the customer with an ROI. The solution consisted of a 442-31 Split Seal with Hard faces/Viton O-rings, 9K acetal bushings to support the shaft and a Chesterton SP50 Flow meter to help manage the flush flow/pressure supplied to the mechanical seal.

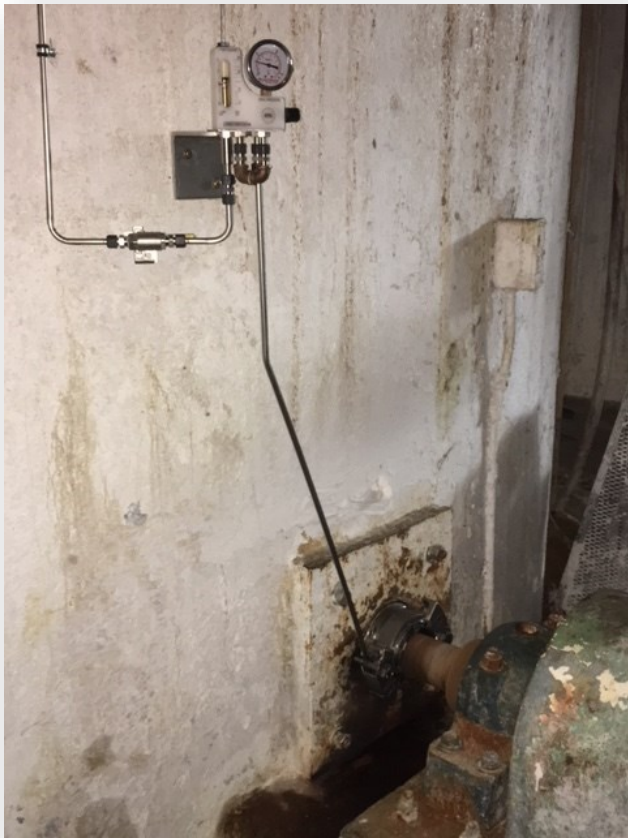
The 442 was installed in early October 2016 and has not leaked a drop since. Customer has saved thousands of dollars and no longer endures leakage/treatment costs from leakage. Success of the application has lead to many other 442 upgrades around the mill.
