# Process Drainage Trench

## Concrete Repair & High Performance Lining

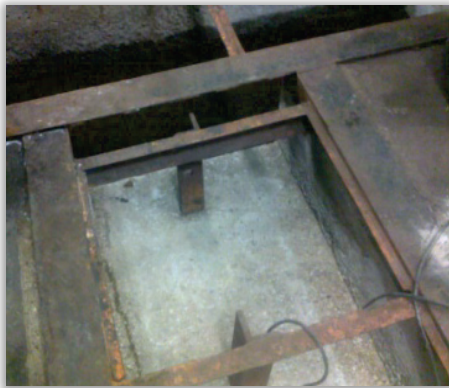
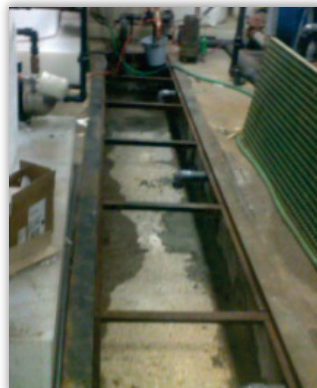
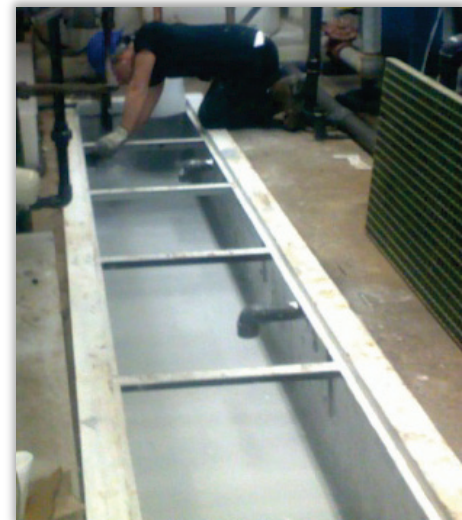
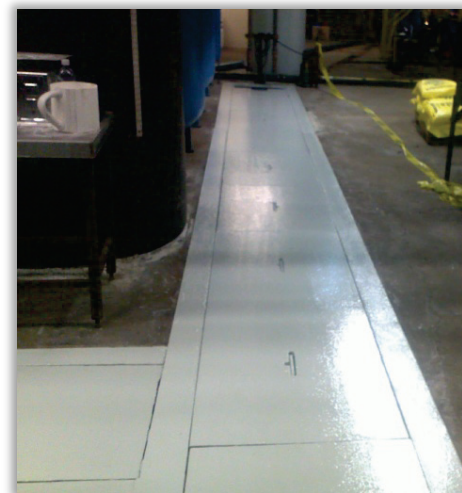
Severely deteriorated concrete and corroded steel frame, previous concrete patches were not effective in the acidic environment.

- Abrasion Blast
- Diamond Grinding
- Back build with chemical resistant Epoxy mortar
- Multiple coats of a chemical resistant high performance Novolac coating

With our 2 stage preparation and high performance epoxy based mortar and coating, CPE not only can restore concrete surfaces but improve their resistance to aggressive chemicals and minerals
